### Bonded Fibre Reinforced Polymer Strengthening in a Real Fire

# **Bonded Fibre Reinforced Polymer Strengthening in a Real Fire**

T.J. Stratford<sup>\*</sup>, M. Gillie, J.F. Chen and A.S. Usmani

Institute for Infrastructure and Environment, School of Engineering, The University of Edinburgh, UK.

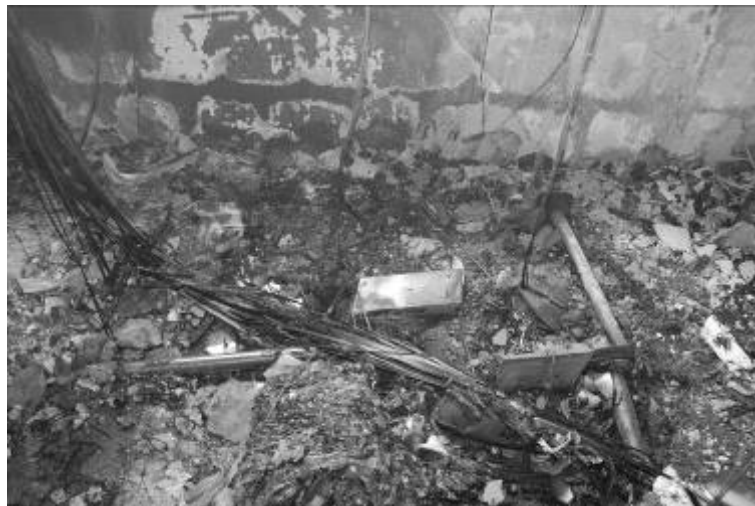
- The unprotected plate (Figure 9a) had completely separated from the concrete. Both the bonding adhesive and the matrix polymer had burnt away, leaving exposed concrete on the ceiling and a bundle of exposed fibres on the floor.

9(a) Remains of the unprotected plate (Test 1)

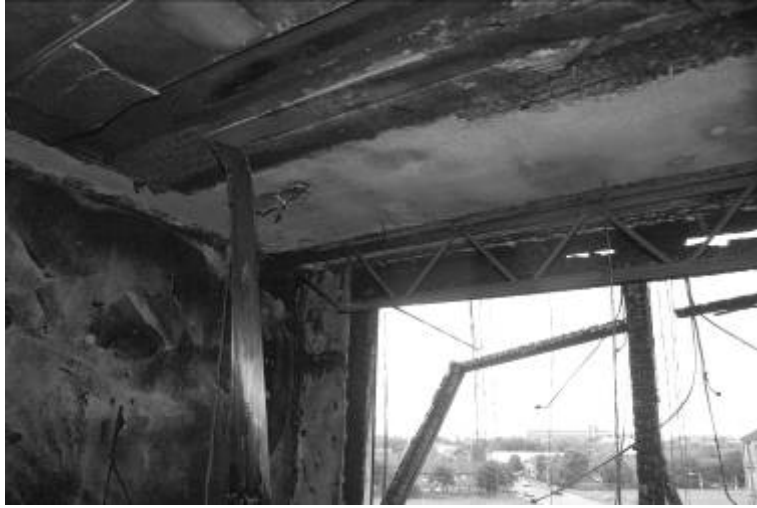
- The intumescent protected plate (Figure 9b) also separated from the concrete, except for a short length at its southern end, where it remained bonded to the concrete. Away from the southern end, the matrix polymer had burnt away to expose the fibres. The bonding adhesive that remained on the ceiling was charred. It should be noted that the gas phase temperatures show a cool region in the south west corner of the room. This is also evident in Figure 8 which shows less heat flux in the south.

9(b) Remains of the intumescent-protected plate (Test 1)

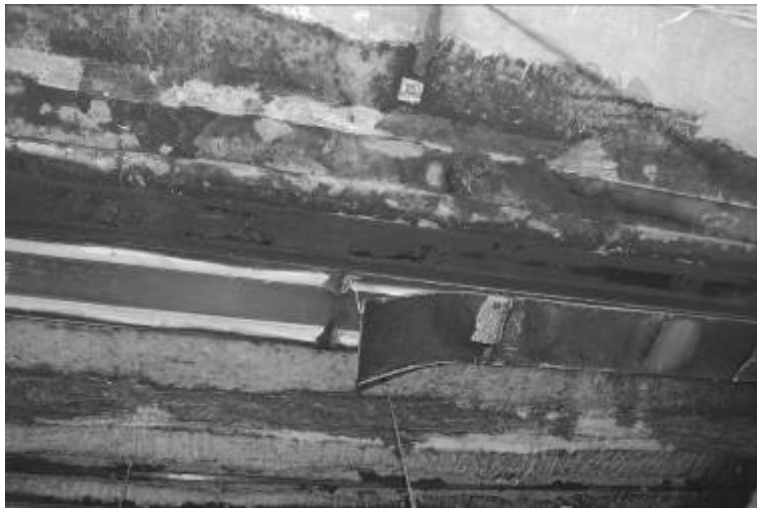
- The gypsum-board protection was fully intact after the tests, with no visible holes in the protection or signs that the fire had penetrated it. After the board was removed (Figure 9c), the plate was found to be fully bonded to the concrete, and there was no *visual* damage to either the plate or the adhesive.

9(c) Gypsum-board-protected plate, protection removed after fire to expose plate (Test 1)

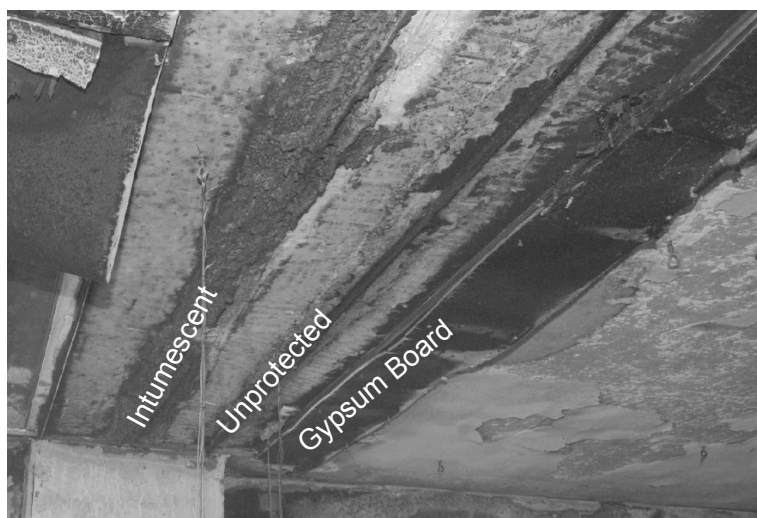
- The adhesive around the unprotected NSM bar (Figure 9d) had burnt away, leaving the FRP partially exposed, but the matrix polymer had not burnt away.

- The intumescent coating over the NSM strengthening (Figure 9d) had been activated. The strengthening beneath the intumescent was in place, although the adhesive was glazed and contained thin transverse cracks.

- The gypsum-board protected NSM (Figure 9d) remained intact, and the strengthening beneath was visually unaltered.

9(d) NSM strengthening after Test 1

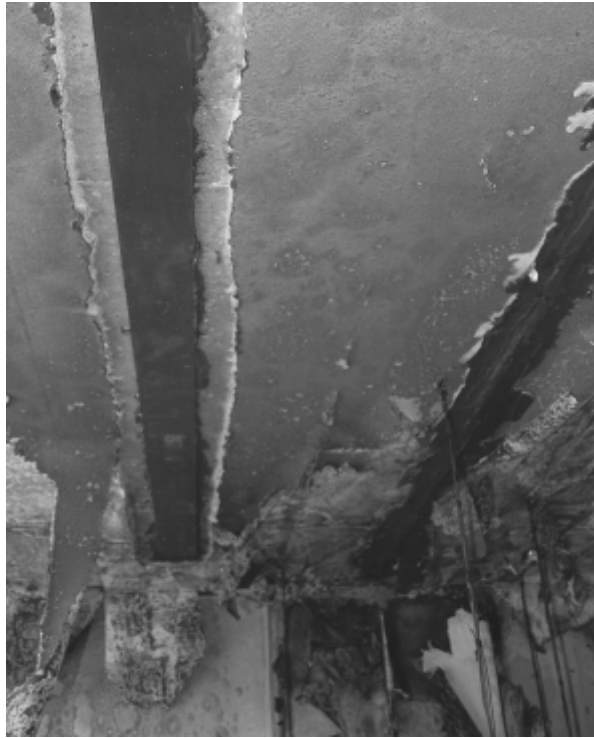
In Test 2 (the ‘Controlled Fire’), both the unprotected FRP plate and NSM strengthening were *visually* unaffected by the fire: the strengthening and adhesive remained in place, their colour had not changed, and there was no sign of crazing of the adhesive (Figure 9e). The FRP plate was easily removed by hand and the NSM was also removed with some assistance using hand tools. It was not possible to carry out mechanical tests to quantify the post-fire properties of the FRP components or the residual pull-off strength of the bonding adhesive after the fires.

9(e) The plate (left) and NSM (right) strengthening after Test 2
